#### Sound Transmission Class (STC) calculation according to ASTM E413 Assessment of Laboratory Transmission Loss per ASTM E90

#### Classification for Determination of Impact Insulation Class (IIC) according to ASTM E989 Assessment of Laboratory Impact Sound Transmission per ASTM E492

## E8741.01-113-11-R0 ACOUSTICAL PERFORMANCE TEST REPORT ASTM E 90, ASTM E 492, ASTM E 2179

Series/Model: 305 mm (12") Square Ceramic Tile on Pliteq GenieMat™ RST12 Rubber Underlayment

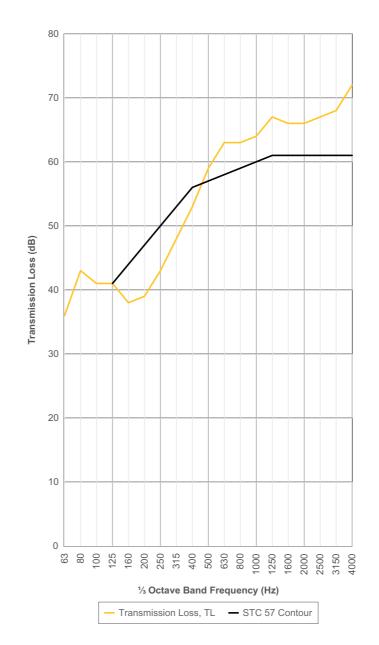
Freq (Hz)	TL (dB)	Def (dB)
50	37	20. (42)
63	36	
80	43	
100	41	
125	41	0
160	38	6
200	39	8
250	43	7
315	48	5
400	53	3
500	59	0
630	63	0
800	63	0
1000	64	0
1250	67	0
1600	66	0
2000	66	0
2500	67	0
3150	68	0
4000	72	0
5000	74	
6300	78	
8000	80	
10000	82

STC = 57 Sum of Def. (dB) = 29

# 8 mm Ceramic Tile

12 mm Pliteq GenieMat® RST12 203 mm Concrete Slab

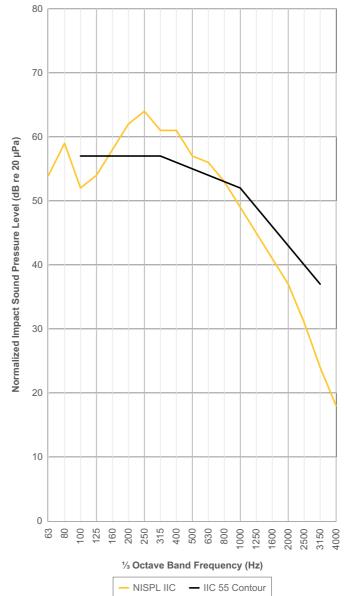
**Test Report Number** e8741.01-113-11-R0 **Tested Assembly** 8 mm Ceramic Tile

12 mm Pliteq GenieMat® RST12 203 mm Concrete Slab

Freq (Hz)	NISPL (dB)	Def (dB)
50	50	Del (ub)
63	54	
80	59	
100	52	0
125	54	0
160	58	1
200	62	5
250	64	7
315	61	4
400	61	5
500	57	2
630	56	2
800	53	0
1000	49	0
1250	45	0
1600	41	0
2000	37	0
2500	31	0
3150	24	0
4000	18	
5000	14	
6300	11	
8000	10	
10000	11

IIC = 55 Sum of Def. (dB) = 26

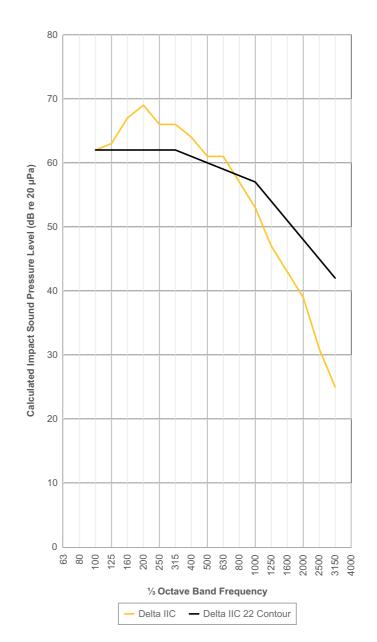
Freq (Hz)	L <sub>ref,c</sub> (dB)	Def (dB)
100	62	0
125	63	1
160	67	5
200	69	7
250	66	4
315	66	4
400	64	3
500	61	1
630	61	2
800	57	0
1000	53	0
1250	47	0
1600	43	0
2000	39	0
2500	31	0
3150	25	0

Delta IIC = 22 Sum of Def. (dB) = 27

8 mm Ceramic Tile 12 mm Pliteq GenieMat® RST12 203 mm Concrete Slab

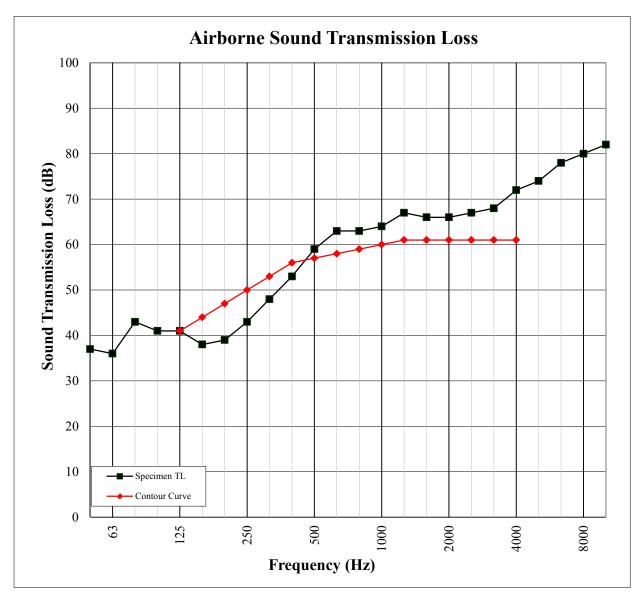
# AIRBORNE SOUND TRANSMISSION LOSS ASTM E 90

<b>Test Date</b>	06/15/15
Data File No.	E8741.01A
Client	Pliteq Inc.
Description	8 mm (0.31") Daltile Ceramic Tile, 12 mm (0.47") Pliteq GenieMat™ RST12 Rubber Underlayment, 203.2mm (8") Concrete Slab
Specimen Area	10.98 m <sup>2</sup>
Technician	Jordan Strybos

Freq	Background	Absorption	Source	Receive	Specimen	95%	Number
rreq	SPL	Absorption	SPL	SPL	TL	Confidence	of
(Hz)	(dB)	$(m^2)$	(dB)	(dB)	(dB)	Limit	Deficiencies
50	42.8	25.3	102	63	37	4.50	-
63	49.3	29.7	101	62	36	2.90	-
80	57.7	17.7	109	65	43	3.30	-
100	43.7	12.0	111	71	41	2.40	-
125	40.5	9.6	112	73	41	1.70	0
160	36.5	8.7	112	76	38	1.70	6
200	29.4	11.2	108	70	39	1.50	8
250	28.6	10.5	107	64	43	0.80	7
315	27.9	10.0	111	65	48	0.90	5
400	26.1	8.6	107	56	53	0.40	3
500	23.1	8.0	105	49	59	0.40	0
630	22.1	7.8	107	46	63	0.30	0
800	24.1	7.9	106	46	63	0.30	0
1000	22.4	7.8	106	45	64	0.40	0
1250	21.8	7.8	106	42	67	0.30	0
1600	17.5	8.1	106	43	66	0.30	0
2000	10.8	9.1	106	42	66	0.40	0
2500	8.0	9.6	105	41	67	0.30	0
3150	6.7	10.3	105	37	68	0.50	0
4000	5.4	11.8	105	33	72	0.40	0
5000	5.5	13.6	104	30	74	0.50	-
6300	6.0	17.1	99	20	78	0.70	-
8000	6.3	22.5	98	16	80	0.90	-
10000	6.5	28.0	94	9	82	0.70	-

STC Rating 57 (Sound Transmission Class)

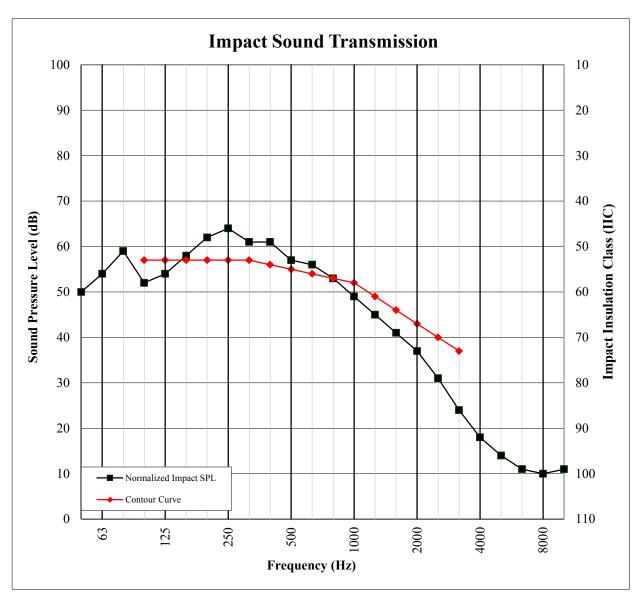
## IMPACT SOUND TRANSMISSION ASTM E 492

Test Date	06/15/15
Data File No.	E8741.01A
Client	Pliteq Inc.
Description	8 mm (0.31") Daltile Ceramic Tile, 12 mm (0.47") Pliteq GenieMat™ RST12 Rubber Underlayment, 203.2mm (8") Concrete Slab
Specimen Area	10.98 m²
Technician	Jordan Strybos

Freq	Background SPL	Absorption	Normalized Impact	95% Confidence	Number	
			SPL		of	
(Hz)	(dB)	(m²)	(dB)	Limit	Deficiencies	
50	44.1	24.7	50	2.7	-	
63	50.6	27.4	54	2.5	-	
80	59.1	16.1	59	5.2	-	
100	44.5	12.0	52	2.6	0	
125	40.6	9.1	54	1.0	0	
160	35.6	8.7	58	1.9	1	
200	29.4	10.7	62	2.2	5	
250	28.5	10.1	64	0.7	7	
315	27.7	9.8	61	1.4	4	
400	26.0	8.5	61	0.8	5	
500	23.2	8.0	57	1.2	2	
630	22.5	7.8	56	1.0	2	
800	24.3	7.9	53	0.5	0	
1000	22.1	7.8	49	1.3	0	
1250	22.5	8.0	45	1.5	0	
1600	18.0	8.0	41	0.6	0	
2000	11.8	9.1	37	0.9	0	
2500	9.2	9.6	31	0.9	0	
3150	7.7	10.3	24	0.7	0	
4000	6.4	11.9	18	1.1	-	
5000	6.1	13.5	14	1.5	-	
6300	6.3	17.1	11	1.1	-	
8000	6.4	22.7	10	0.7	-	
10000	6.5	28.2	11	0.9	-

IIC Rating55(Impact Insulation Class)Deficiencies26(Sum of Deficiencies)

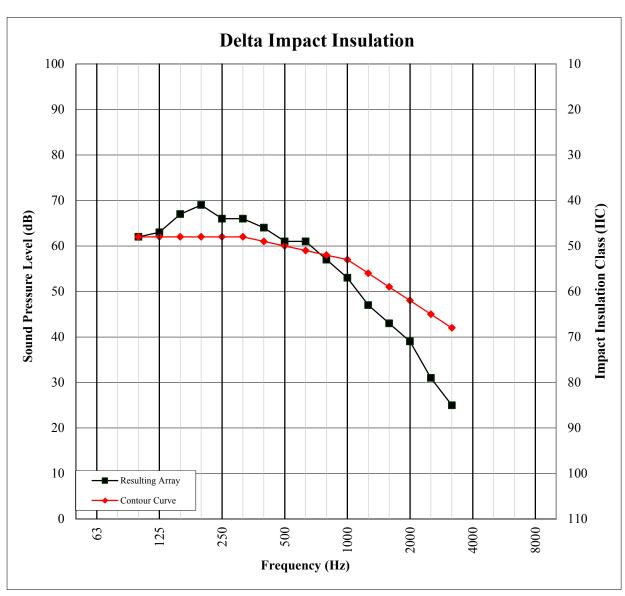
# DELTA IMPACT INSULATION

Test Date	06/15/15
Data File No.	E8741.01A
Client	Pliteq Inc.
Description	8 mm (0.31") Daltile Ceramic Tile, 12 mm (0.47") Pliteq GenieMat™ RST12 Rubber Underlayment, 203.2mm (8") Concrete Slab
Specimen Area	10.98 m <sup>2</sup>
Technician	Jordan Strybos

E	Bkgrd	Absorption	Normalized	95%	Normalized	95%	Resulting	No. of
Freq	SPL	(Square	Impact SPL	Conf	Impact SPL	Conf	Array	Defici-
(Hz)	(dB)	Meters)	BARE (dB)	Limit	SPEC (dB)	Limit	$L_{ref,c}$	encies
100	44.5	12.0	56.8	1.0	51.6	1.4	62	0
125	40.6	9.1	58.5	1.3	53.8	0.9	63	1
160	35.6	8.7	58.6	0.6	57.8	0.3	67	5
200	29.4	10.7	62.2	1.5	62.4	2.4	69	7
250	28.5	10.1	67.5	0.9	64.2	1.9	66	4
315	27.7	9.8	64.1	1.6	60.9	2.9	66	4
400	26.0	8.5	67.1	1.1	60.8	4.1	64	3
500	23.2	8.0	65.8	1.9	56.6	3.1	61	1
630	22.5	7.8	65.7	2.7	55.8	2.8	61	2
800	24.3	7.9	67.5	1.9	52.7	1.7	57	0
1000	22.1	7.8	68.1	1.6	49.5	1.6	53	0
1250	22.5	8.0	69.5	1.8	44.6	2.4	47	0
1600	18.0	8.0	70.0	1.6	40.7	0.7	43	0
2000	11.8	9.1	70.7	1.0	37.3	0.6	39	0
2500	9.2	9.6	71.2	2.0	30.5	0.5	31	0
3150	7.7	10.3	71.1	3.9	24.2	0.2	25	0

ΔIIC Rating 22 (Delta Impact Insulation Class)

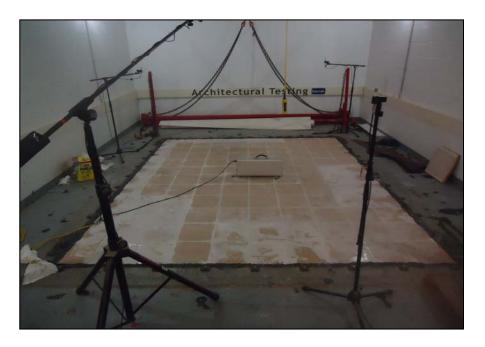
**Source Room View of Test Specimen Installation**

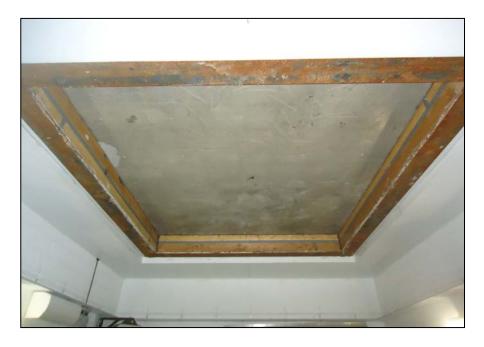
**Receive Room View of Test Specimen Installation**
